**BUILDING SURVEYOR'S REPORT  
- EXTERNAL CONDITION  
SURVEY AT THAME MUSEUM  
THAME TOWN COUNCIL  
04.09.2019**

### **EXTERNAL CONDITION SURVEY AT THAME MUSEUM THAME TOWN COUNCIL**

04.09.2019

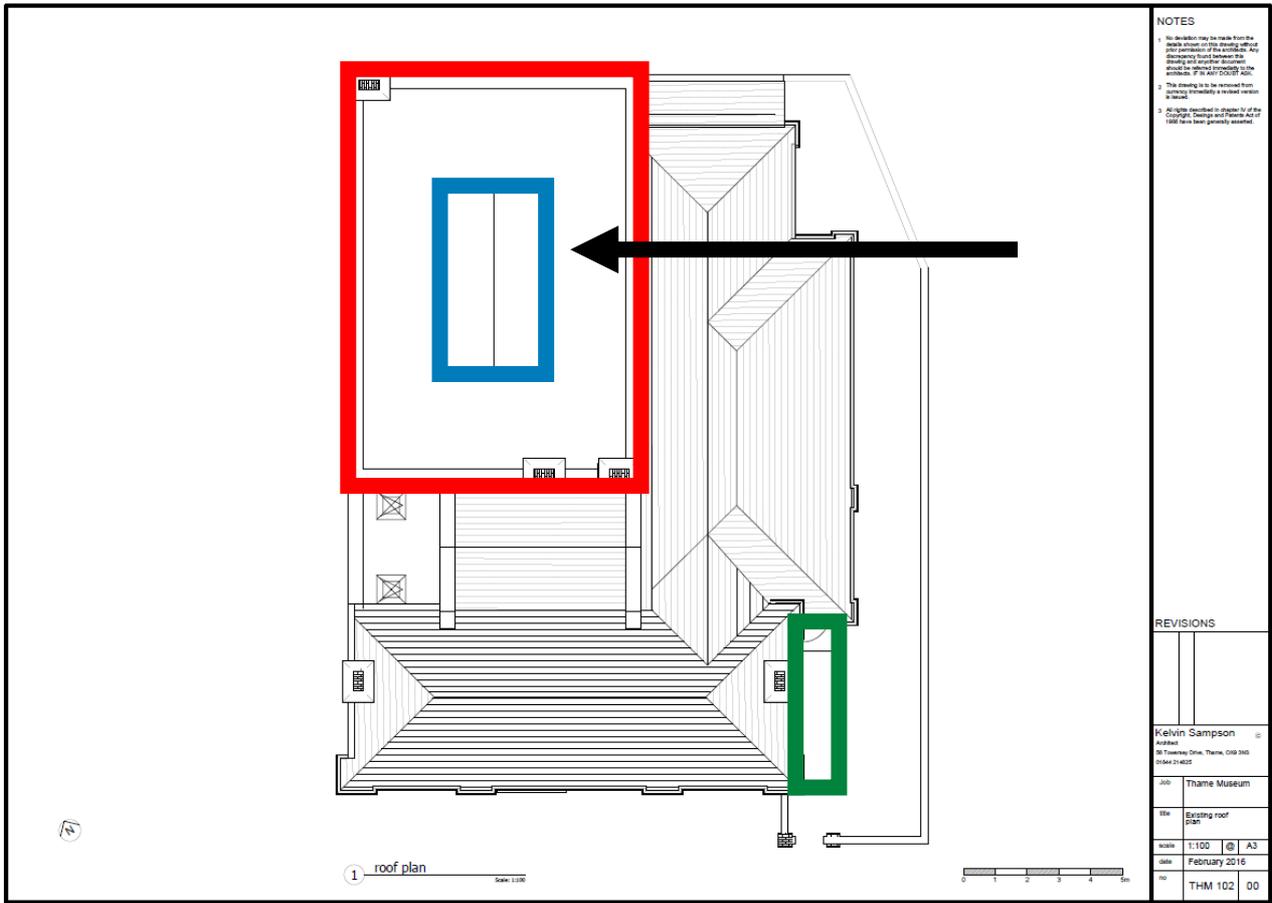
5.1. Appendix 1 – Building Plan

There is evidence of ongoing ponding to the roof with corresponding damp staining to internal ceiling finishes, as shown in the area with the black arrow on the appended roof plan, however we believe water ingress is likely caused by the roof lantern and lead cover flashings rather than the lead flat roof. See photographs 8, 9 and 10.

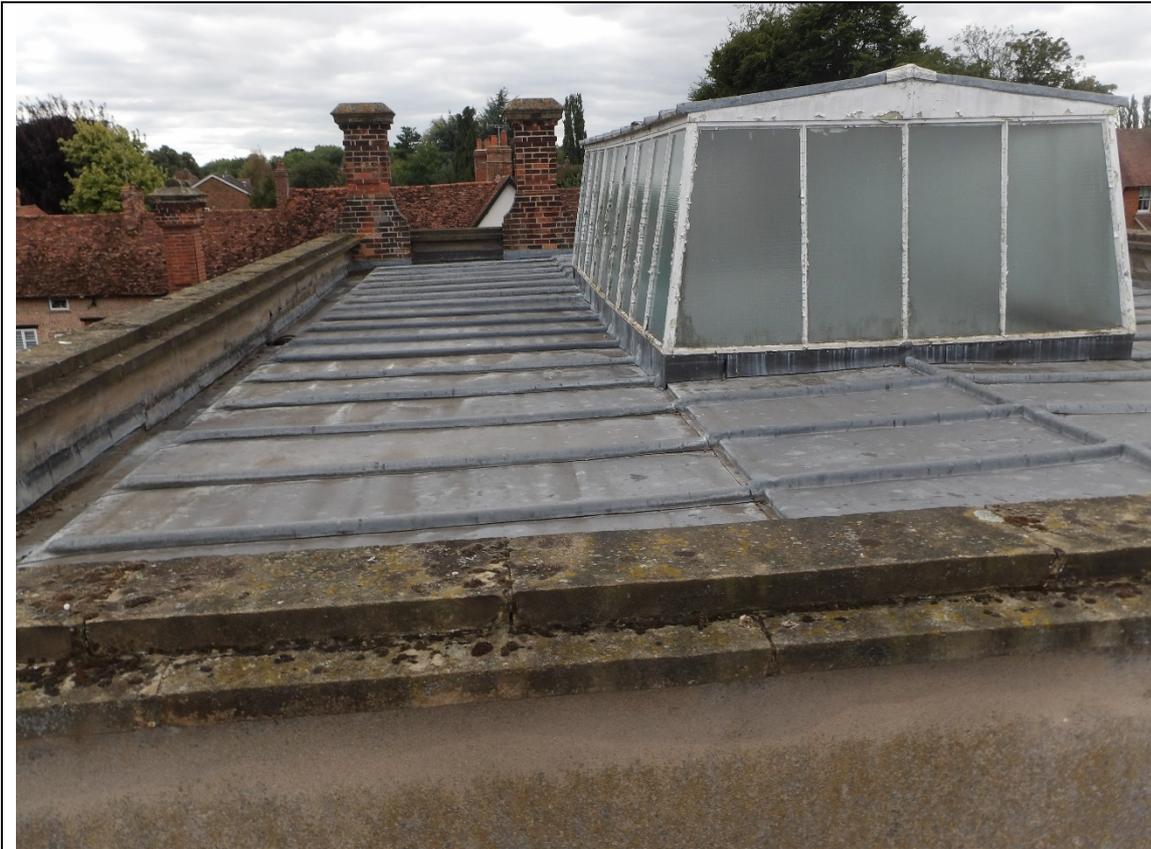
To the rear of Thame Museum there is a single glazed timber framed roof lantern providing natural light to the double height museum exhibition space below as shown blue on the appended roof plan. A decorated timber frame surrounds Georgian wire single glazing with lead covered roof and lead cover flashings dressed over the lead flat roof below. See photograph 5.

Photograph 5 – Single glazed timber framed roof lantern.

We recommend further investigations to the roof lantern and lead cover flashings junction by forming temporary scaffold followed by an invasive inspection to determine the condition of construction details whilst hopefully carrying out corresponding repairs so as to make full use of the scaffold.

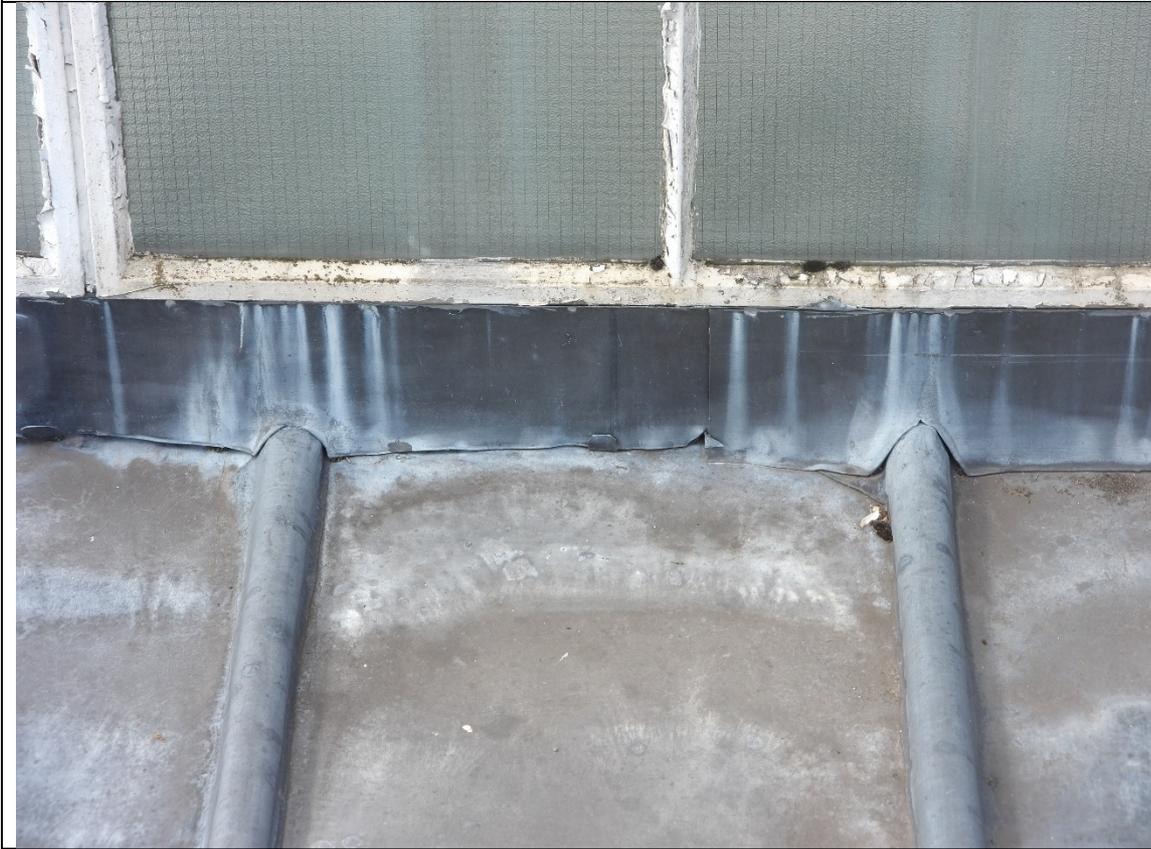
There is evidence that defective glazing putty, timber frame and lead cover flashings are believed to be contributing to water ingress during periods of heavy rainfall in conjunction with the prevailing wind. We were not able to determine the construction detail and robustness of the lead cover flashings in this area with safe access to the first floor roof not possible, however evidence of staining and inadequately dressed and lifting lead flashings at the roof lantern and flat roof junction suggest either an historic or ongoing defect. See photographs 6, 7 and 8.

Photograph 6 – Roof lantern lead cover flashings dressed over lead flat roof below.

Roof lantern and lead cover flashings – scaffold access and further investigations to the lead cover flashings. While temporary access is provided we suggest engaging with a suitable contractor to repair and redecorate the timber framed roof lantern the lead cover flashings.

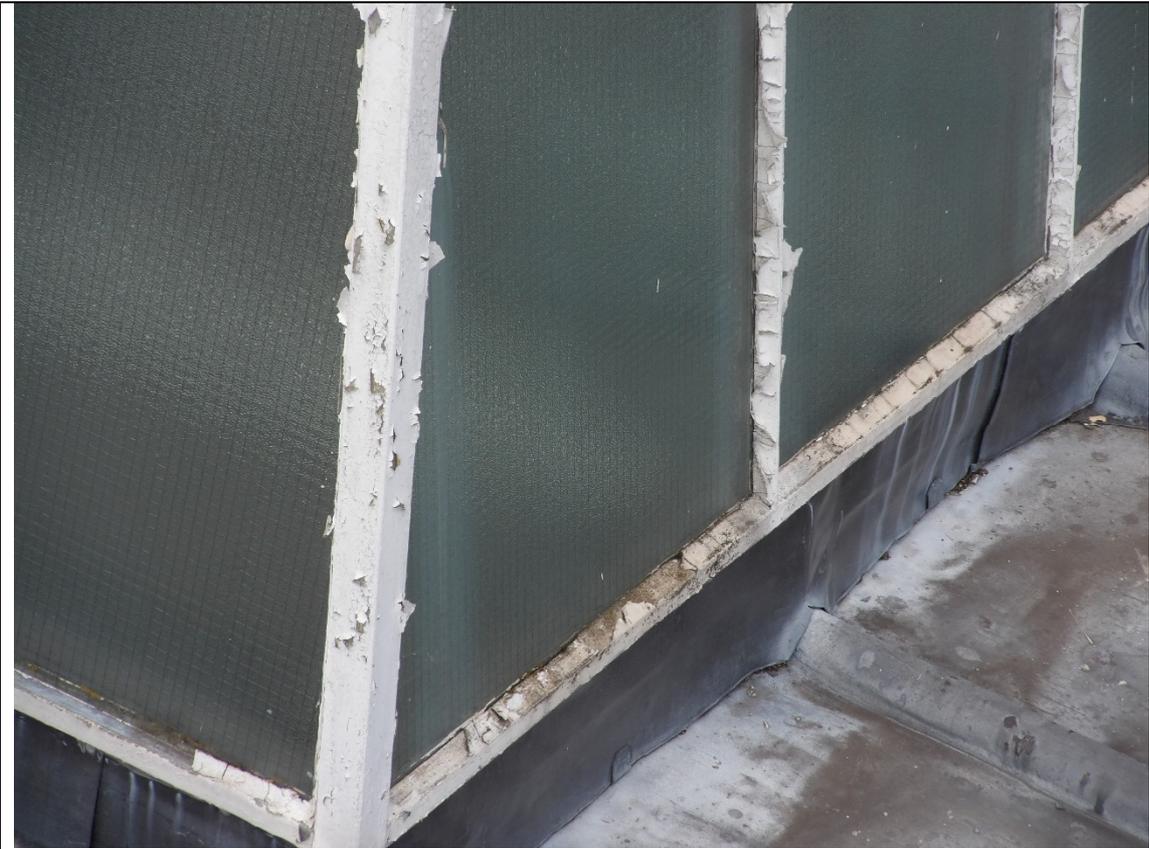
Photograph 7 – Roof lantern missing glazing putty, defective decorative finish and lead cover flashings.

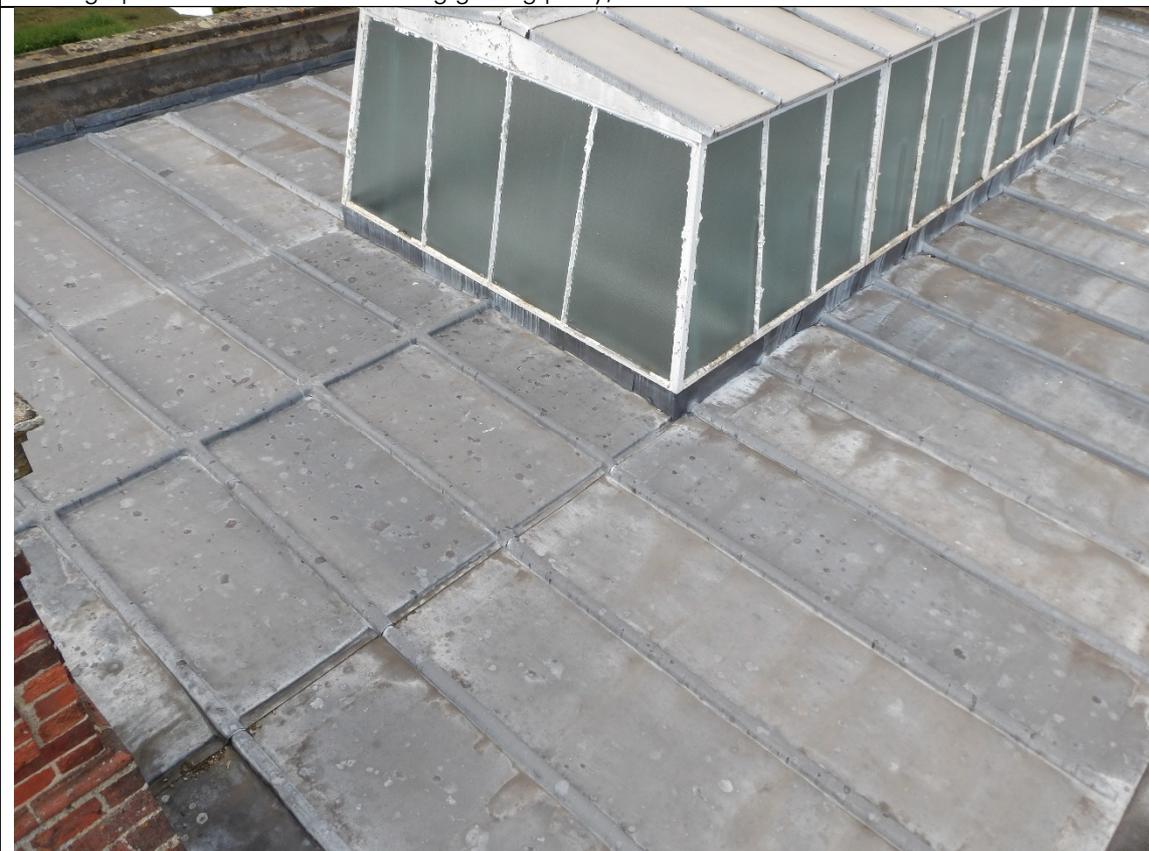
Photograph 8 – Lead covered flat roof with evidence of ponding.

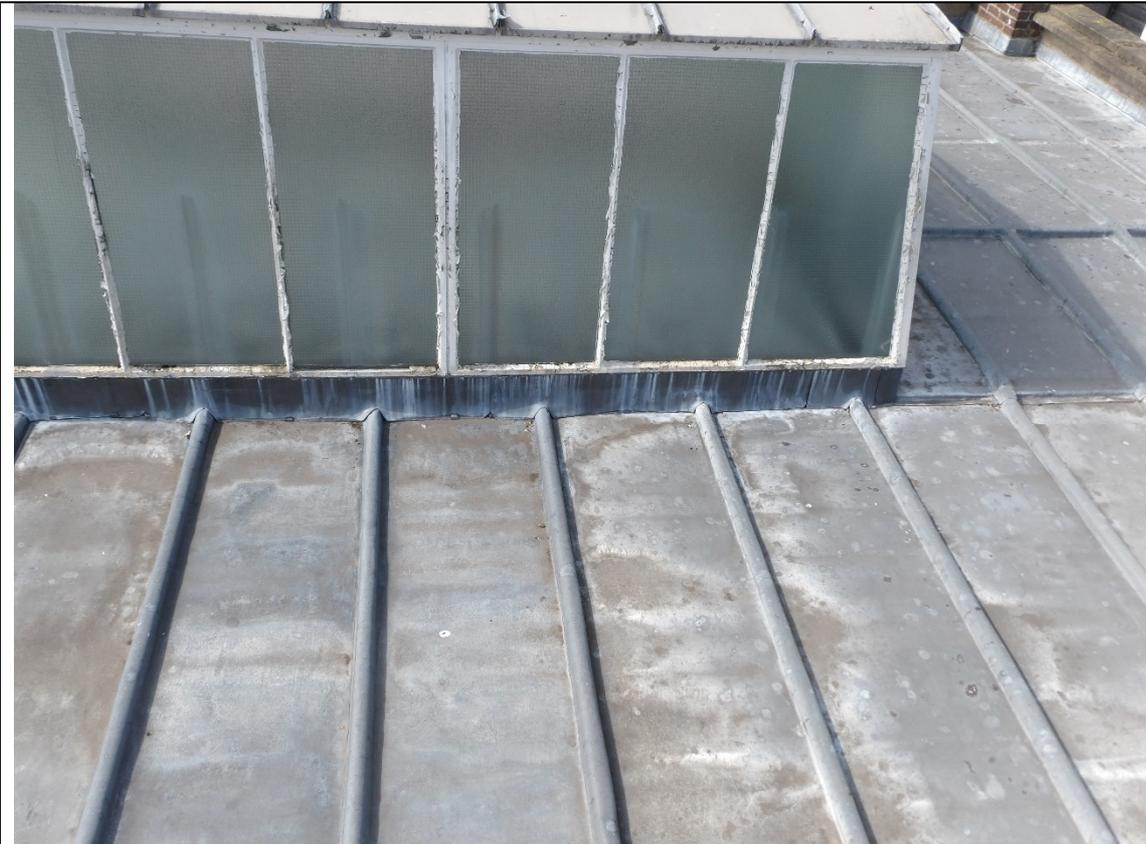
Photograph 9 – Lead covered flat roof with evidence of ponding.

We were not able to determine the construction detail and robustness of the lead covering in this area with safe access to the first floor roof not possible, and believe it sensible to address the visible defects to the roof lantern and lead cover flashings first.

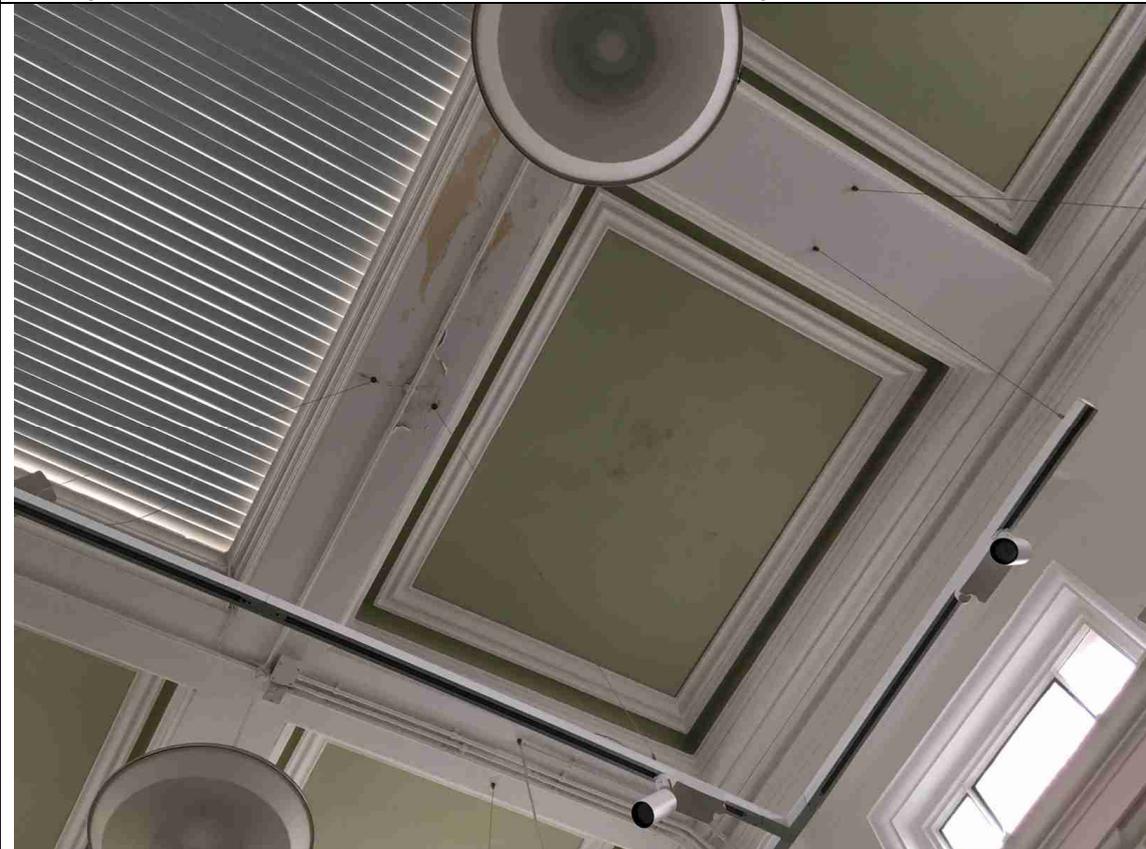
Photograph 10 – Damp staining to internal ceiling finishes.

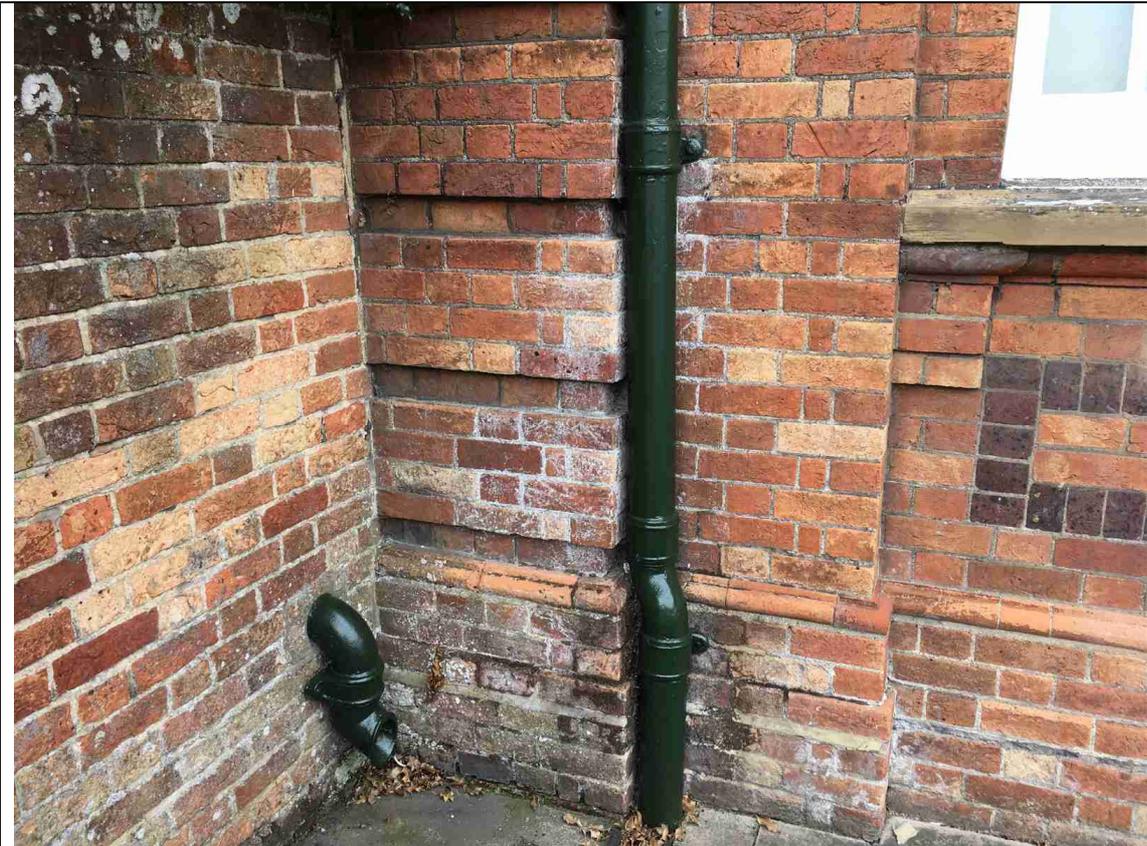
There is evidence that blocked or leaking rainwater goods are causing rainwater to overflow the gutter system and cascade down the south elevation during periods of heavy rainfall. While this was not witnessed at the time of our inspection, evidence of efflorescence salts, vegetation growth and internal damp staining suggest either an historic or ongoing gutter defect. See photographs 11 and 12.

Photograph 11 - Efflorescence salts and vegetation growth to south elevation rainwater downpipe.

Rainwater goods – inspect and clear rainwater gutter system.

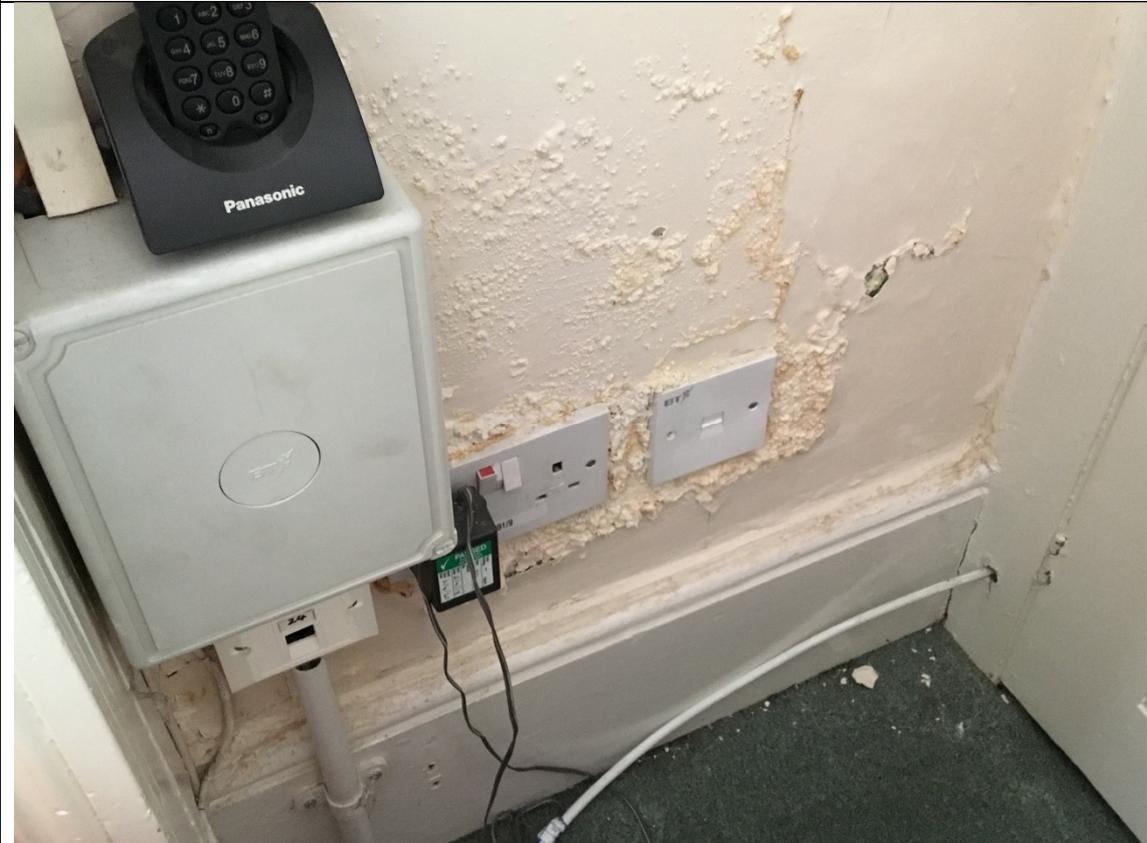
Photograph 12 – Ground floor internal damp staining corresponding to south elevation external rainwater downpipe.

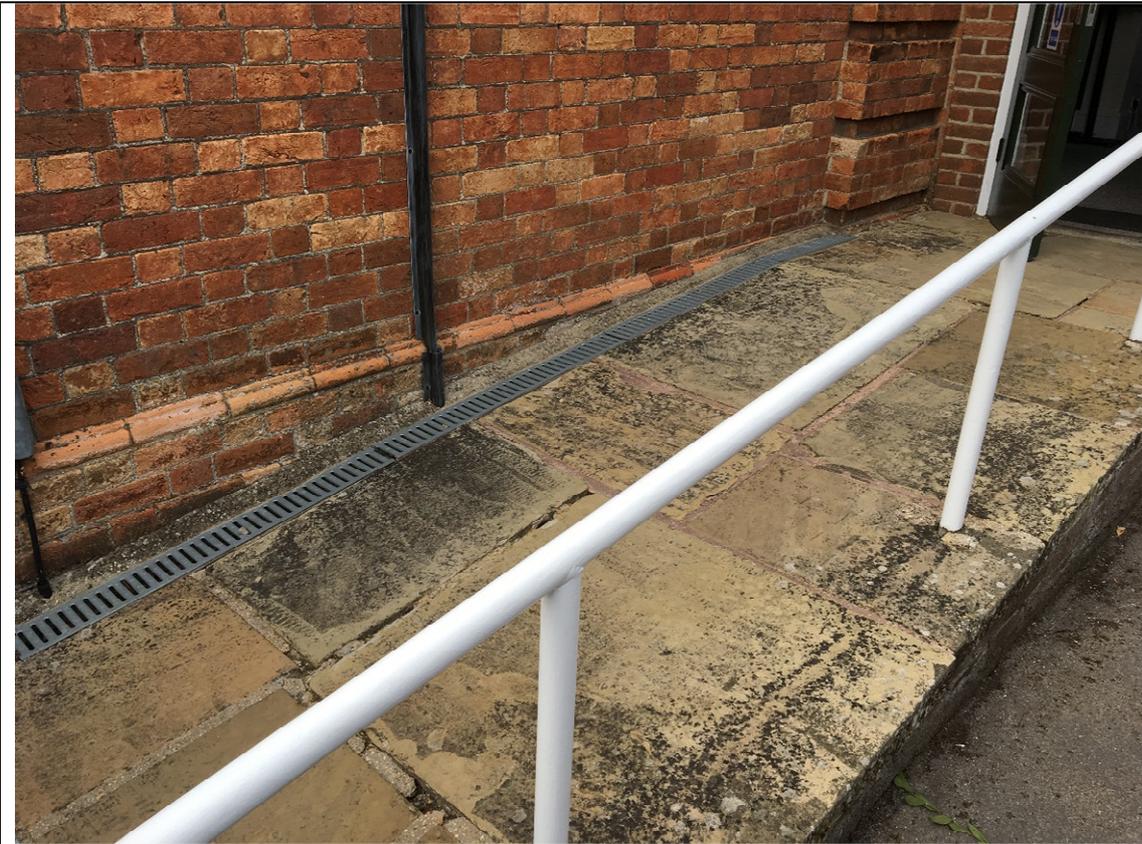
At the junction between the ramp and clay brick elevation we would typically anticipate seeing a vertical DPC with suitable cover flashing or weather detail. Efflorescence and defective pointing to brick masonry and stone paving display signs of ongoing saturation.

A vertical DPC and weather detail were not present potentially resulting in ongoing saturation through the solid wall construction and causing penetrating damp. We were not able to determine the effectiveness of the drainage in this area which may be blocked or damaged for example.

Photograph 13 – Ramped access with Aco drain channel and metal handrail.

Ramp – construct a vertical DPC with weather detail between the brick masonry elevation and ramp to prevent saturation to internal surfaces.

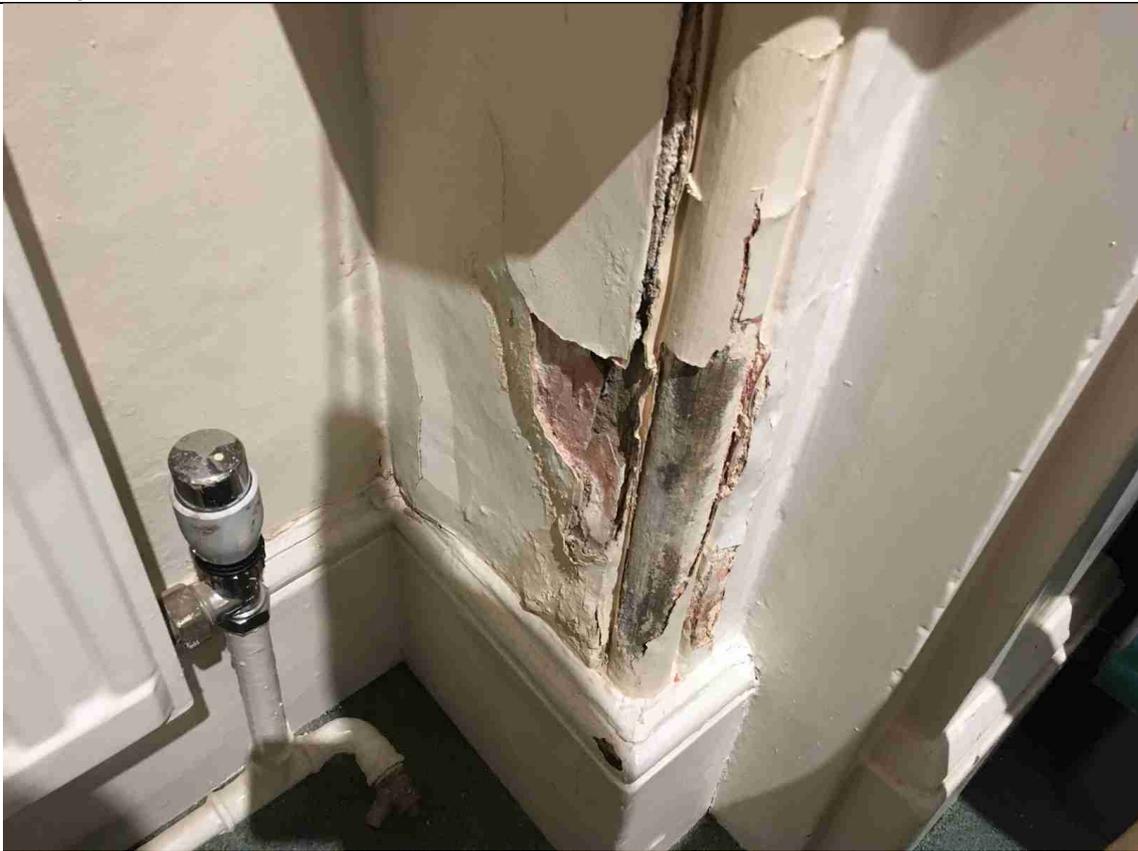
To the internal wall there is evidence of damp staining and blistering, measuring approximately 1m<sup>2</sup>. Internal defects correspond with the location of external ramp. Damp timber skirting and plaster demonstrate continual saturation from an ongoing water ingress defect which may be caused by the lack of a vertical DPC at the block paved ramp abutment.

Photograph 14 – Ground floor damp staining corresponding to external ramp access.

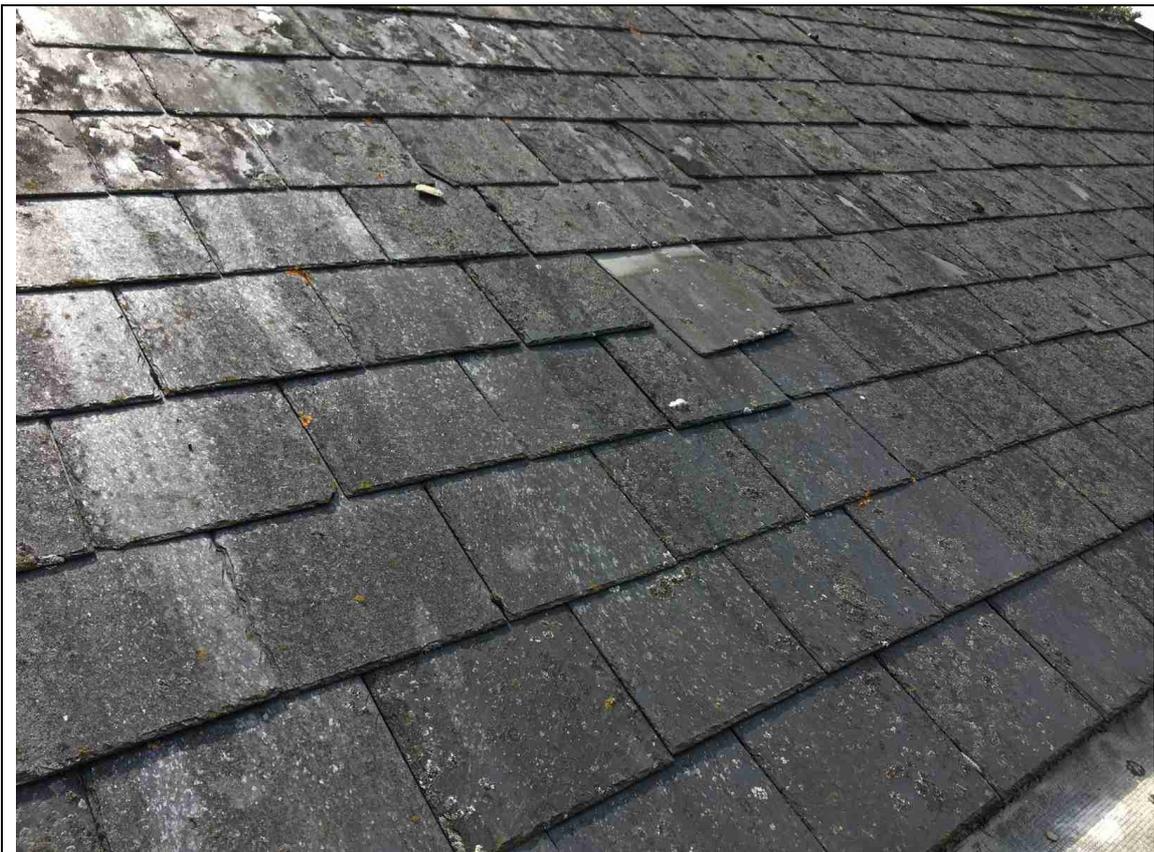
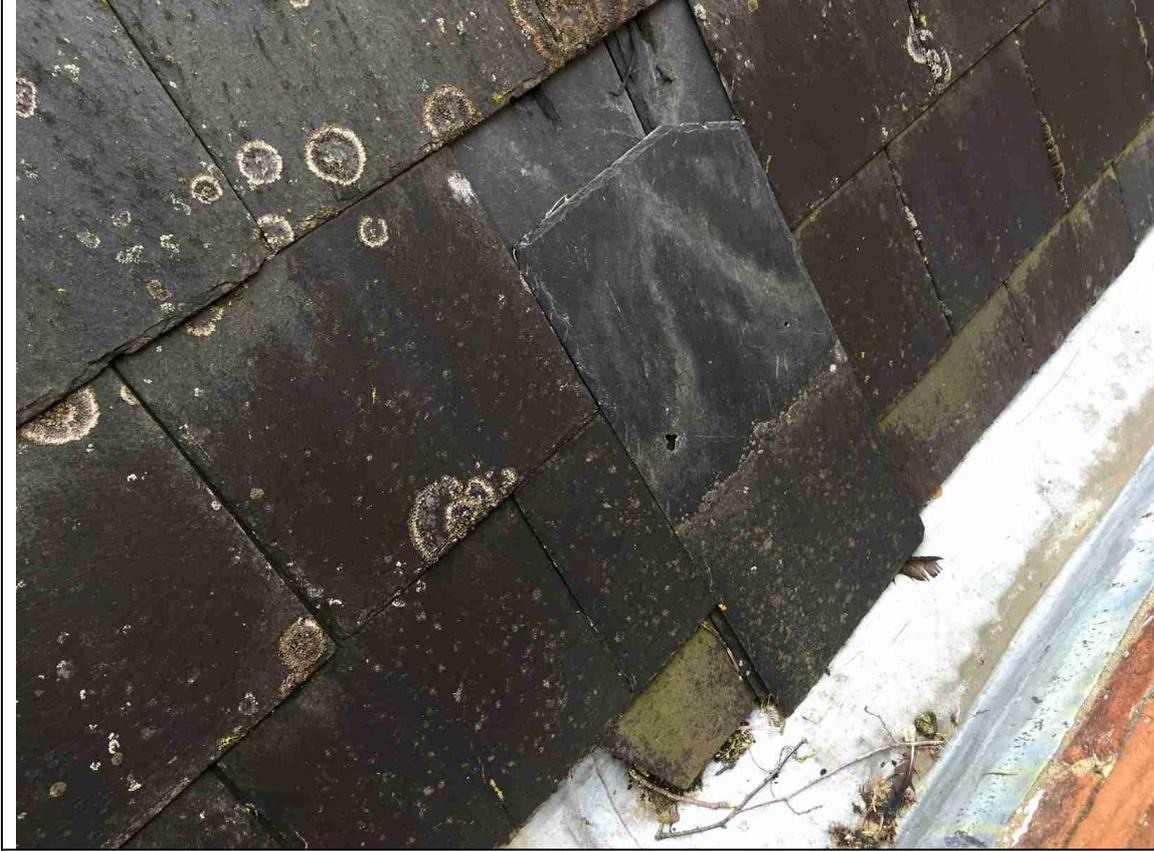
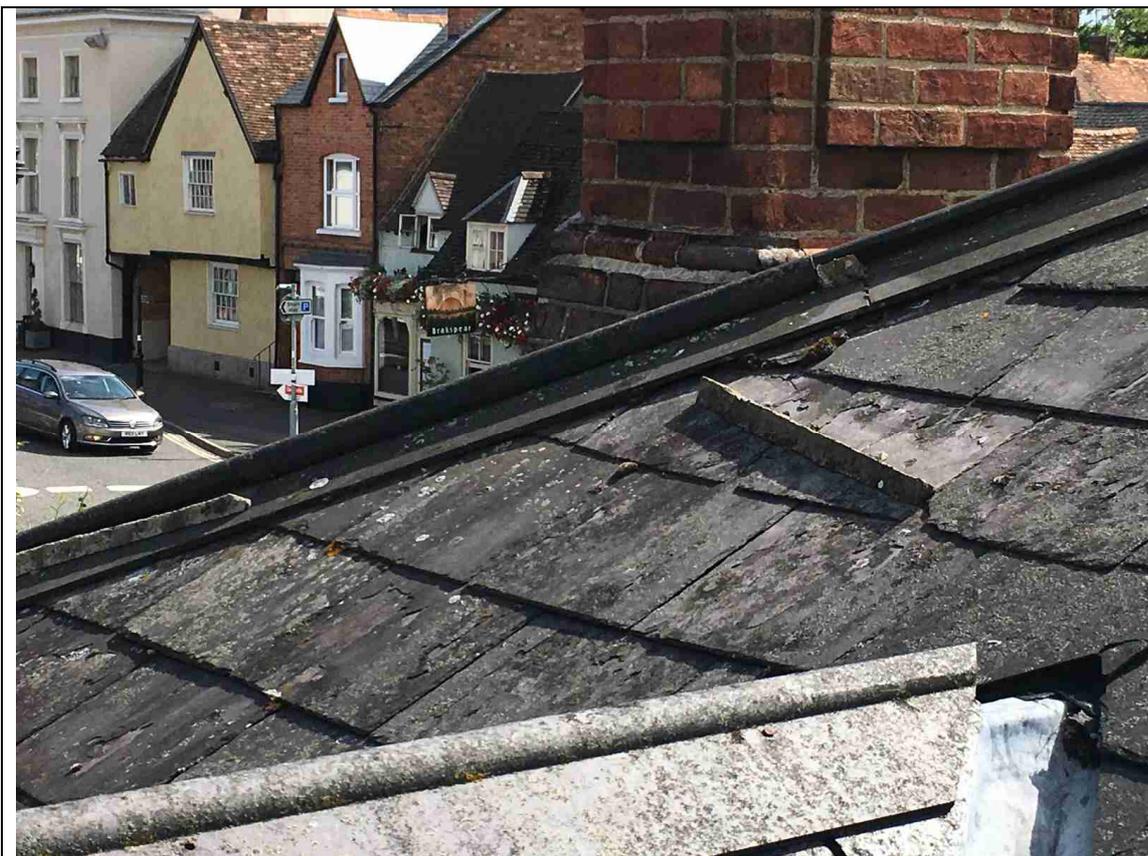
1. Slipped and cracked slates to pitched roofs in multiple location with ridge tiles loose. Slates should be replaced and ridge tiles re-bedded. See photographs 15, 16 and 17.
2. Vegetation growth to rainwater goods to the perimeter of the Museum suggest a blocked or overflowing gutter system during heavy rainfall. Inspection and cleaning should be included in the building's maintenance cycle. See photograph 18.

Photograph 15 – Evidence of slipped roof slates to pitched roof.

Photograph 16 – Evidence of slipped roof slates to pitched roof.

Photograph 17 – Evidence of defective bedding to ridge tiles.

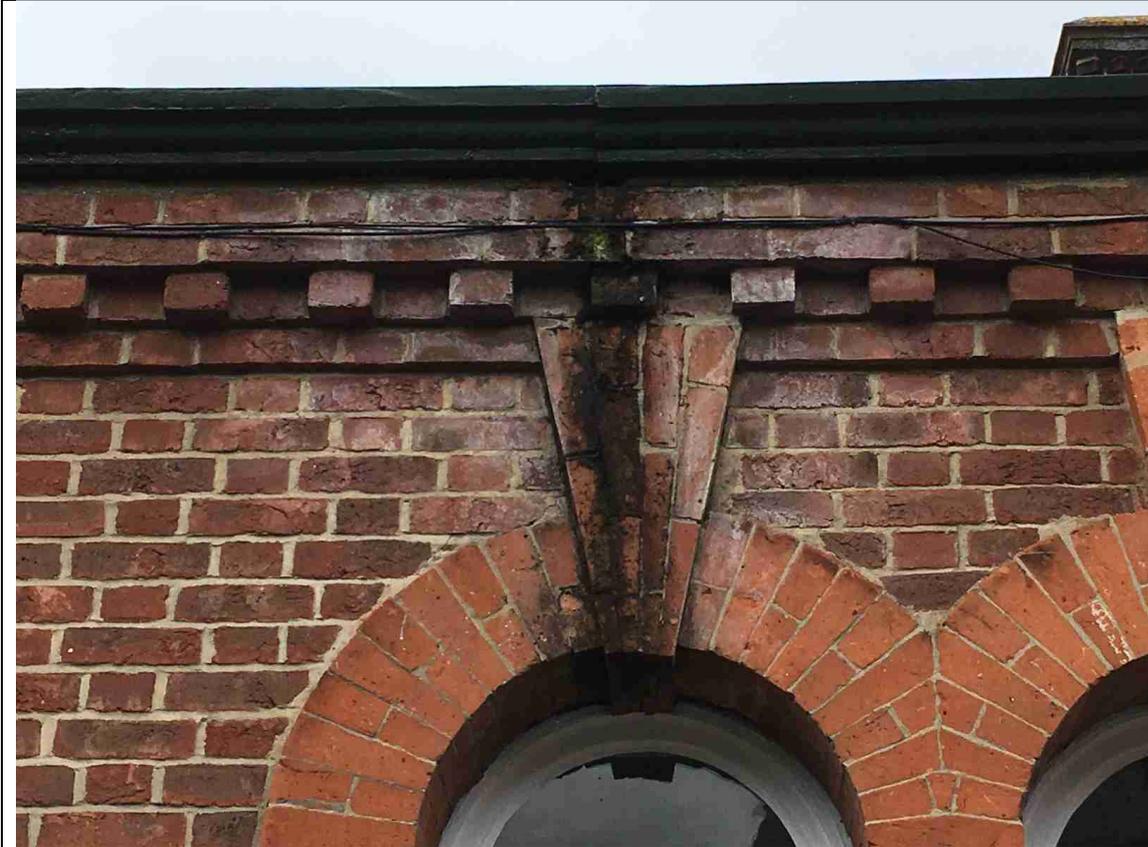
Photograph 18 – Evidence of defective rainwater gutters.
