Thame Museum

Condition Report

79 High Street, Thame, OX9 3AE

Issue: 05/02/2024

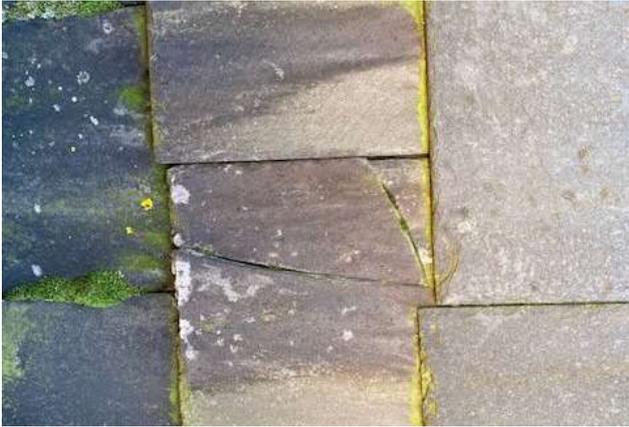
01. Cracked tile to pitched roof in need of replacement.

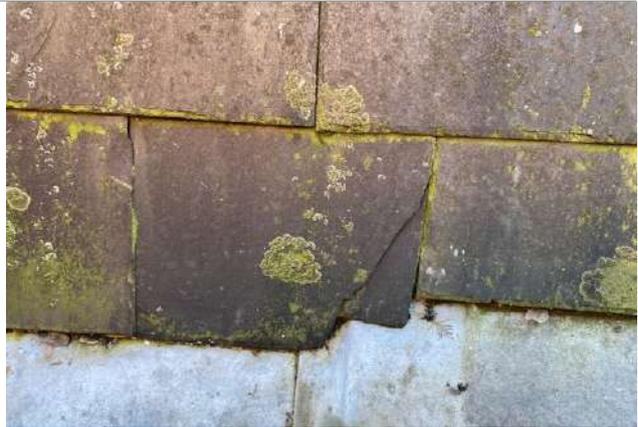
02. Cracked tile and moss growth to pitched roof in need of replacement.

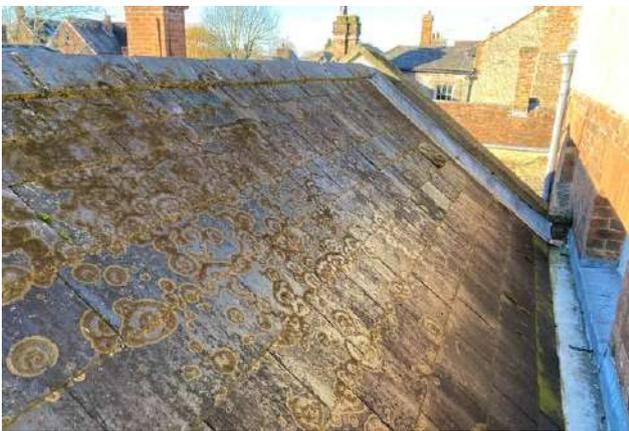
03. Evidence of Lichen build up to pitched roof.

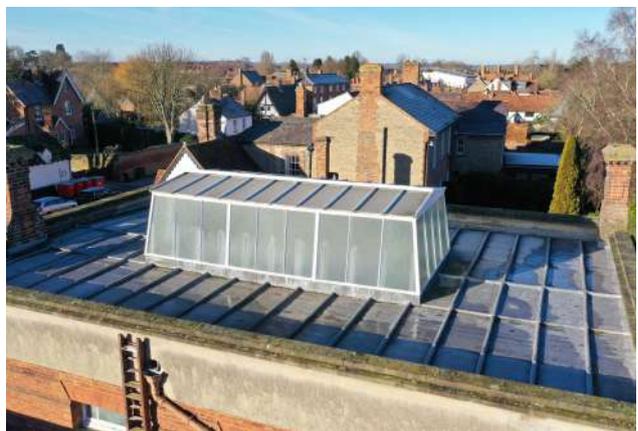
04. General view of glazed roof lantern.

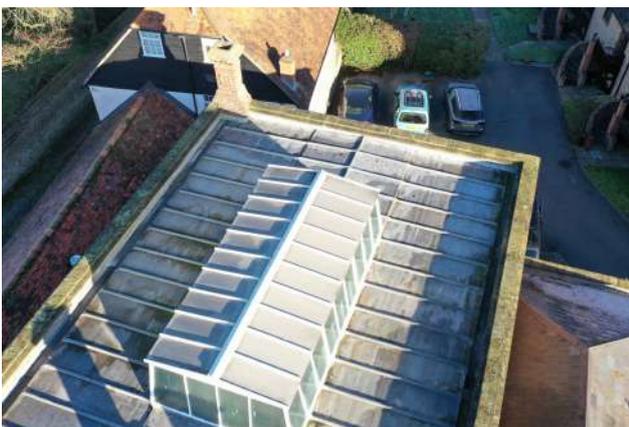
05. General view of flat roof above main gallery.

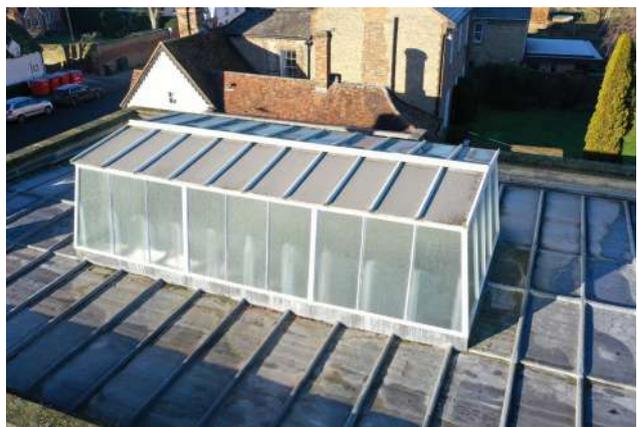
1	1	1.6	Roofs	Roof coverings and insulation	Roof lights/lanterns	C	1	06	Repair	£0.00	£0.00	£0.00	£0.00	£0.00	£0.00	£0.00	£0.00	Glazed roof lantern to main gallery is generally in satisfactory condition for its age and appears to have been well-maintained. Cost for urgent repair works have been included in item 1.4.
1	1	1.7	Roofs	Roofs drainage	Gutters and downpipes	C	2	07	Repair	£1,500.00	£0.00	£1,500.00	£0.00	£0.00	£0.00	£0.00	£0.00	Painted cast iron rainwater goods generally in satisfactory condition and performing as intended however isolated joints are showing signs of failure causing brickwork and mortar to become saturated. A cost has been provided for isolated repairs/replacement to match the existing configuration and colour. The guttering where the pitched roof discharges rainwater to the flat roof over the kitchen appears to have been recently replaced due to a previous failure shown to parapet brickwork.

06. Leak in main gallery caused defective flashing detail.

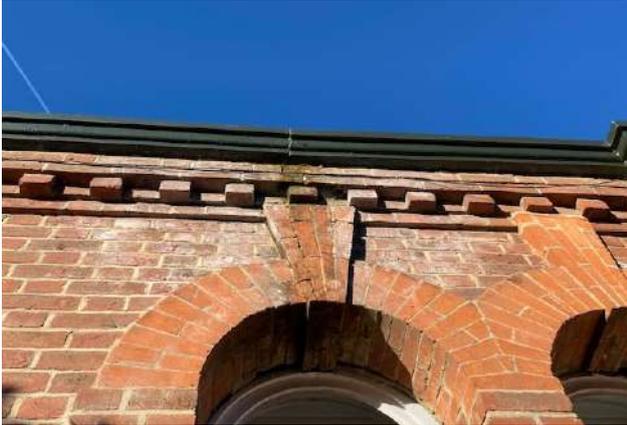
07. Saturated brickwork due to failed joint in rainwater gutter.

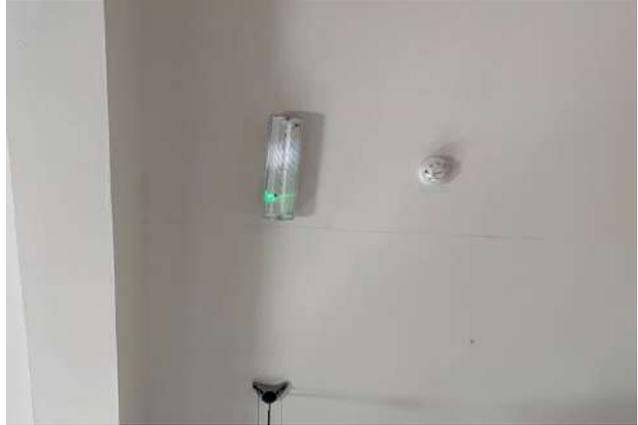
08. Cracking evident to ceiling in exhibition space in need of filling and decoration.

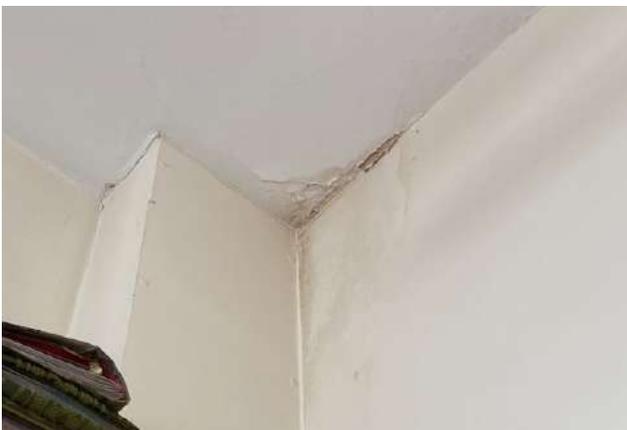
09. Delaminated plaster as a result of historic leak.

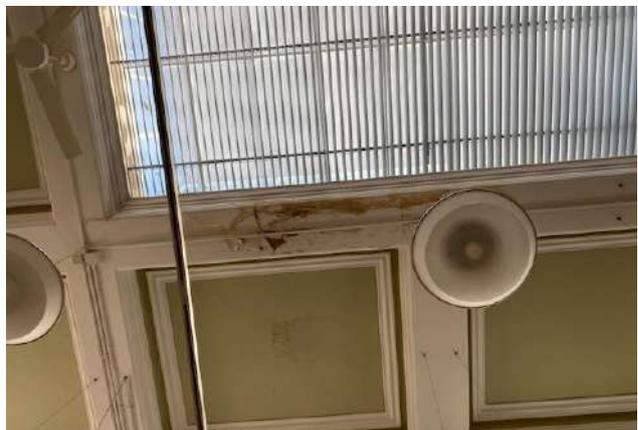
10. Blistered paint to ceiling in main gallery as a result of ongoing leak.

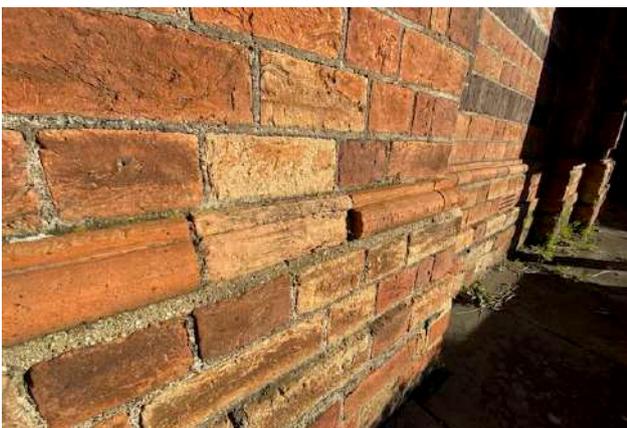
11. Spalled brickwork to low level plinth to exterior walls.

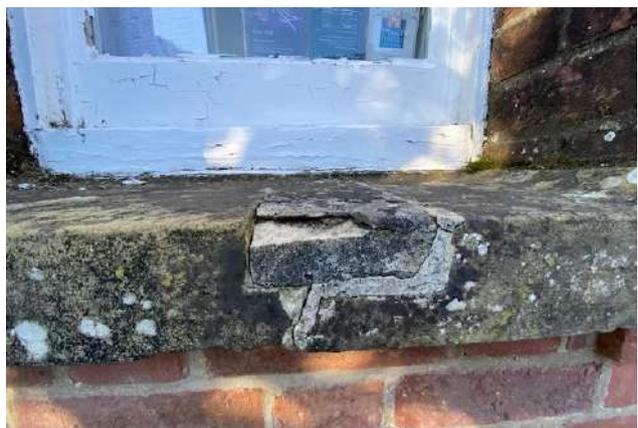
12. Delaminated stone cills and decorations to timber window failing.

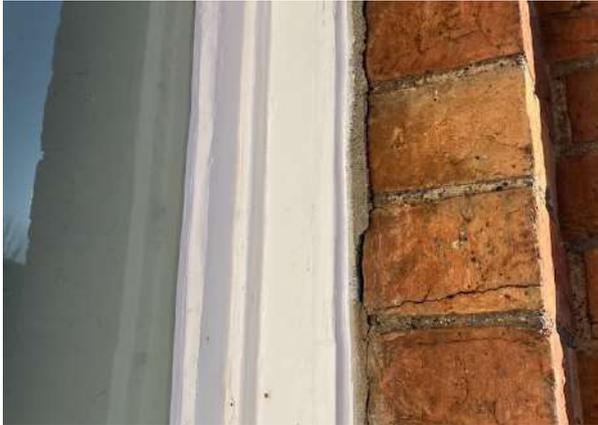
13. Evidence of failed mortar joints to window reveals.

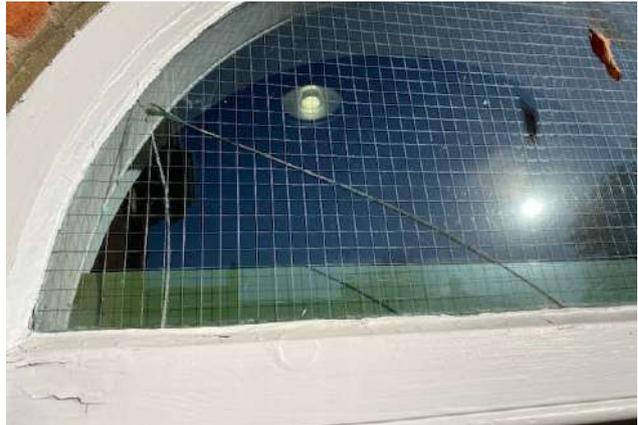
1	4	4.2	External walls, windows and doors	External walls structure	Windows, timber	C	1	14 15 16 17	Repair	£8,000.00	£4,000.00	£4,000.00	£0.00	£0.00	£0.00	£0.00	Single glazed, timber frame sliding sash windows present to the ground floor elevation of Victorian element of the museum appear to be well maintained with only minor signs of worn decoration evident. It was advised by museum staff that all windows were operational, however this was not verified during the inspection. Single glazed, timber frame tilt and turn windows present to high elevation of main exhibition room showing signs of worn/faded decoration and defective putty sealant. Cracking evident to Georgian wired glazing fan light, a cost has been provided in year 0 for immediate repairs/decorations.
1	4	4.3	External walls, windows and doors	External walls structure	Doors, timber	B	4	N/A	Routine	£0.00	£0.00	£0.00	£0.00	£0.00	£0.00	£0.00	External timber doors appear in satisfactory condition and performing as intended with only minor decorations required as part of the museum maintenance schedule.

14. Cracked glazing to fanlight above main entrance door.

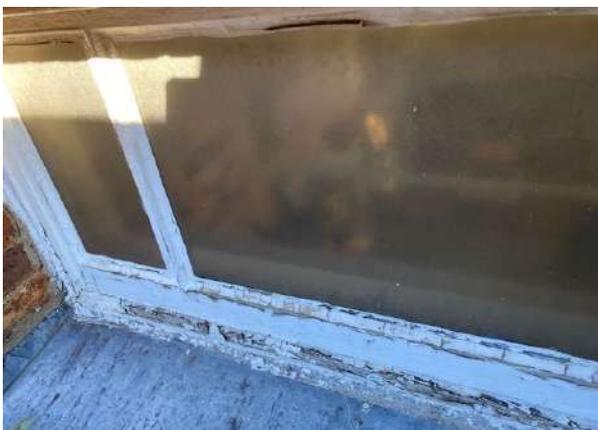
15. Failed/worn decorations to high level windows to main gallery.

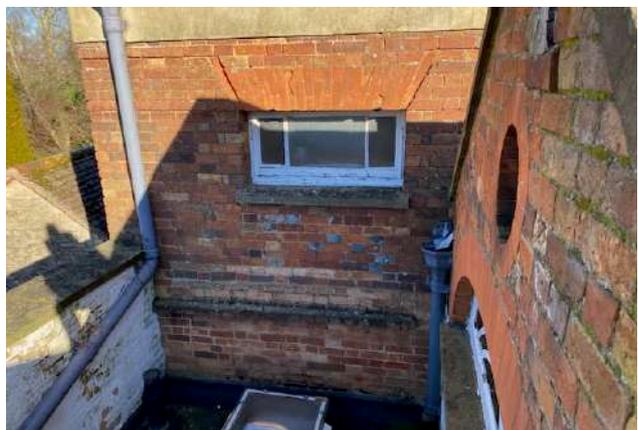
16. Failed/worn decorations to high level windows to main gallery.

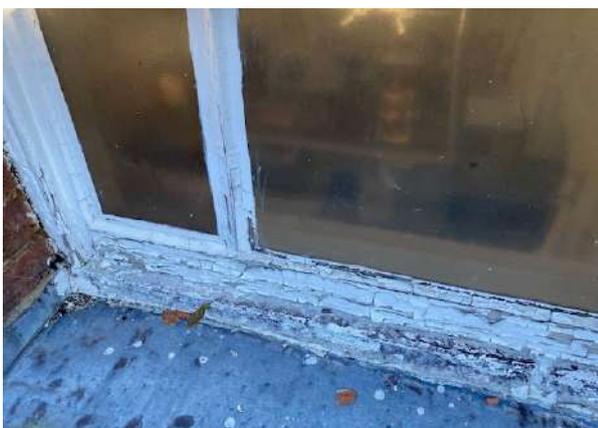
17. Failed/worn decorations to high level windows to main gallery.

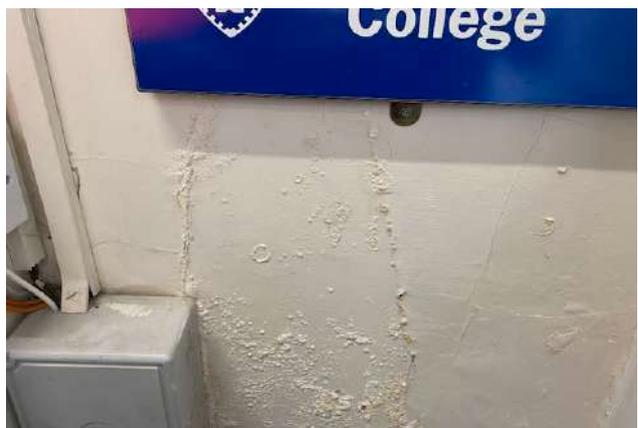
18. Damp present to internal walls in the library and exhibition space.

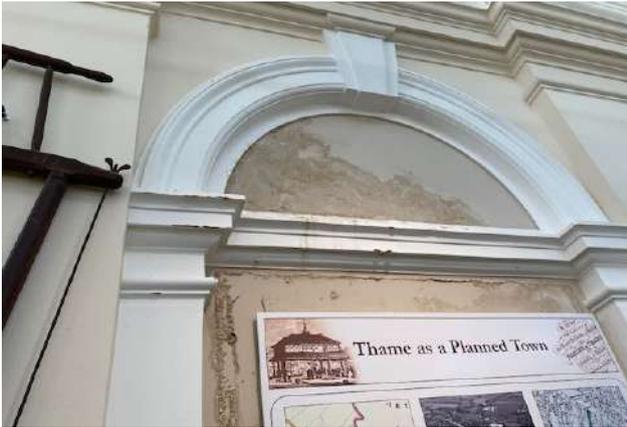
19. Delaminated/blistered paintwork in main gallery as a result of historic leak.

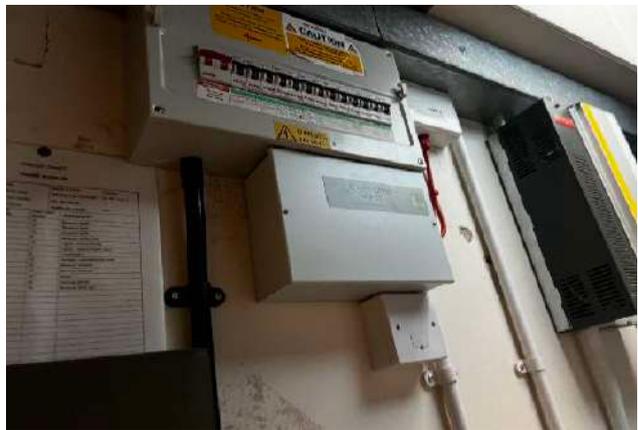
ME3. Distribution boards and lighting dimmers.

Block ref.	Element No.	Item No.	Element	Sub-Element	Item	Condition	Priority	Photo No.	Action	Total Cost	Year 0 (Immediate)	Year 1	Year 2	Year 3	Year 4	Year 5	Description
1	8	8.2	Electrical services	Power	Wall mounted switchgear	C	3	ME3	Replace	£6,000.00	£0.00	£0.00	£0.00	£0.00	£3,000.00	£3,000.00	Distribution boards and MCB boards in reasonable condition albeit approaching the end of their life factor. Allowance to replace MCB boards in years 4 and 5. The main switch gear should be monitored and maintained.
1	8	8.3	Electrical services	Lighting system	Linear and compact fluorescents	C	3	ME4	Replace	£20,000.00	£0.00	£0.00	£0.00	£5,000.00	£5,000.00	£10,000.00	The general lighting is on the whole fluorescent and has limited product support. A rolling programme of replacement is recommended. We note that the display lighting comprising spotlights on track have on the whole been up dated to LED. We note concerns regards the display lighting dimmer equipment approaching the end of its life factor and this should be upgraded allowance included in year 5.

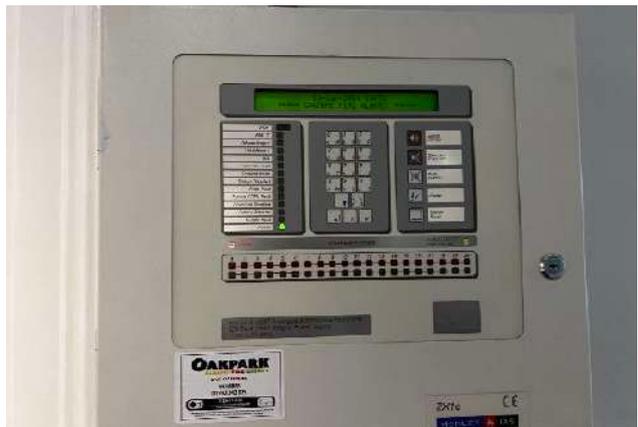
ME5. Fire Alarm

1	8	8.4	Electrical services	Alarms	Intruder detection and fire alarm system	C	3	ME5	Replace	£9,000.00	£0.00	£0.00	£0.00	£0.00	£0.00	£9,000.00	The fire alarm system is circa twenty years old and replacement head end and components should be installed. We have included an allowance to retain and test the existing cabling installation. Cost indicated in year 5.
1	8	8.5	Electrical services	Communications & IT infrastructure	Telecoms and access control systems	C	3	N/A	Replace	£9,500.00	£0.00	£0.00	£4,000.00	£5,500.00	£0.00	£0.00	There is local CAT 5 distribution to WIFI and data outlets. Intruder detection and circa 9 cameras to the CCTV systems. We have allowed for replacement intruder detection and CCTV systems in years 2 and 3 as the installations are at the end of their life factor.
1	9	9.1	Redecorations	External redecorations	Windows, doors, soffits, fascia's, rainwater goods	B	3	N/A	Cyclical	£5,000.00	£0.00	£0.00	£0.00	£5,000.00	£0.00	£0.00	Most external painted surfaces are generally in satisfactory condition. Allow for a cyclical redecoration programme based on c.4 year intervals to maintain aesthetics and prolong lifecycle.
