Thame Museum

Condition Report

79 High Street, Thame, OX9 3AE

Issue: 05/02/2024

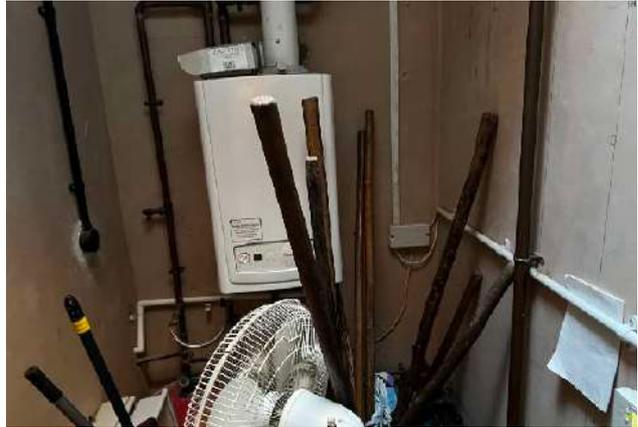
ME1. Boiler Plant

- Boilers: Gas fired LTHW boilers is aged approximately 15 years and although operational is approaching the end of its usable life. This boilers should be considered for replacement within the next 5 years to remove the risk of failure or availability of parts.
- Most of the museum lighting is fluorescent, although operational the lighting is approaching the end of its economic life factor and a rolling programme of replacement should be implemented.
- Electrical distribution and MCB boards are approaching the end of their serviceable life with consideration to replace within the reporting period.
